BRISTOL RESERVOIR DAM
CT. 00008

PHASE I INSPECTION REPORT
NATIONAL DAM INSPECTION PROGRAM

Identification Number:	CT 00008
Name:	Bristol Reservoir Dam
Town:	Bristol
County and State:	Hartford County, Connecticut
Stream:	Pequabuck River
Date of Inspection:	September 21, 1978

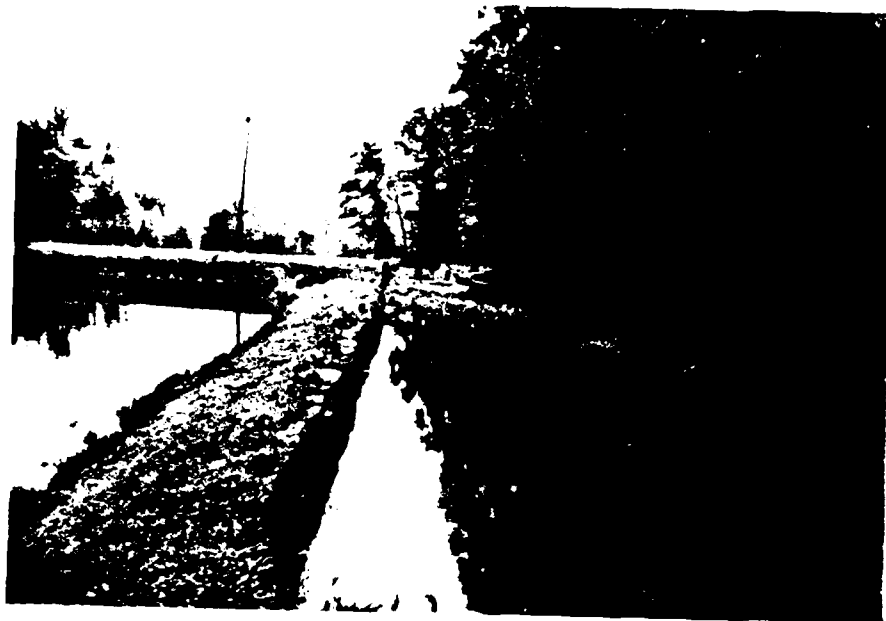
PHOTO 3
SPILLWAY LOOKING DOWNSTREAM

c. Appurtenant Structures - The appurtenant structures are the spillway, the diversion conduit and the spillway channel. The fieldstone spillway shown in Appendix C, Photos 3 and 4, appears to be in fair condition with a considerable amount of grass growing through the mortar joints.

There is need for some restoration of the spillway because there are some areas of structural distress. This distress is the cracking of walls and some spalling. There are two valves at the toe of the dam. The upper valve is always open.

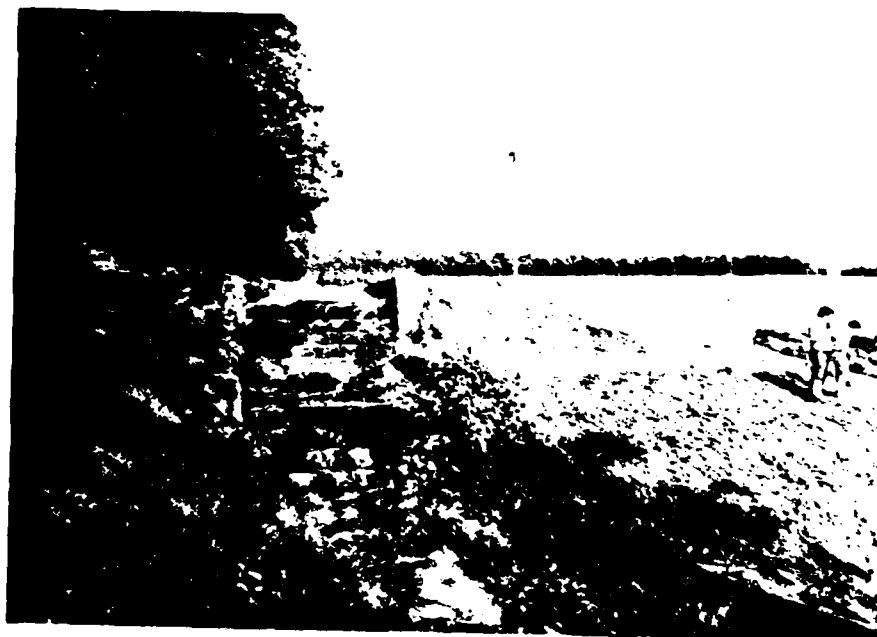
PHOTO 4
SPILLWAY LOOKING UPSTREAM

c. Visual Observations - The spillway at the time of the inspection was in fair condition with evidence of water seepage at the lower end and grass and brush growing up through joints (Appendix C, Photo 4).
